TAIL LIGHT PROTECTIVE COVER

by Dave DuBois

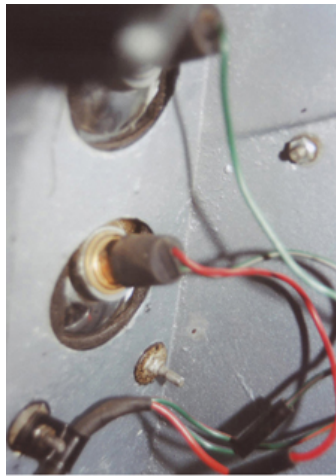
BEFORE

During two trips from the Seattle area to Southern California, I had a problem with the electrical system in our 1966 MGB. Whenever I applied the brakes I noticed that the tach would drop off to almost 0 RPM and the head light warning buzzer that I had installed would come on. Upon investigation, I found that the camera case that I had crammed into the trunk, in the fender well, directly behind the right hand wheel well, was hard against the tail light/brake light/turn signal assembly and was causing the wire to the brake light to be crushed against the socket hard enough to cause a short to ground. Since we take the MGB on all extended trips (our only other vehicles are a TD and a beater truck), I had to come up with a way to protect the tail light, brake light and turn signal sockets. The following is what I came up with and you may want to apply it to your '64 through '69 MGB (a similar fix would work on the later MGBs, but I don't have the dimensions for them).

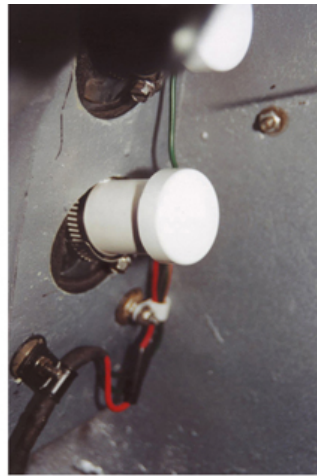
AFTER

Since putting these protective covers on the tail light sockets of our MGB, we have had no further problems with shorted brake lights regardless how tightly packed the trunk is (sardine cans are loosely packed compared to the trunk of our car when we set out on a two to three week trip).
